TECHNICAL REPORT GL-87-14

SEISMIC STABILITY EVALUATION OF FOLSOM DAM AND RESERVOIR PROJECT

Report 2 INTERFACE ZONES

Geotechnical Laboratory

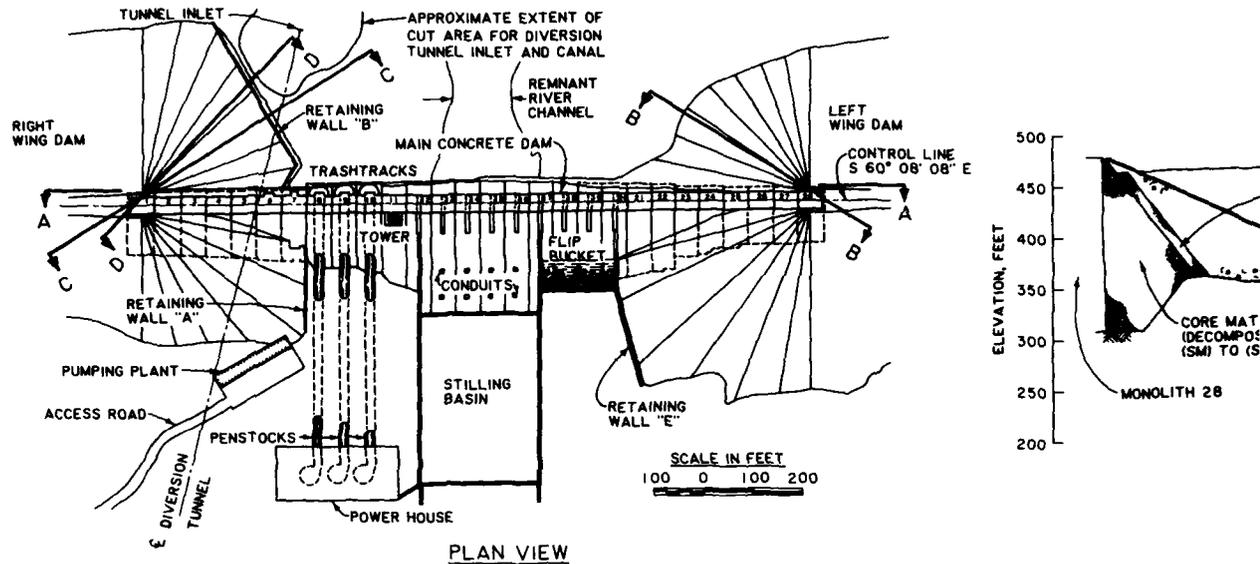
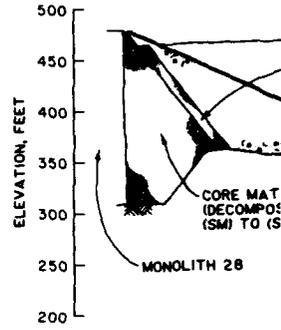
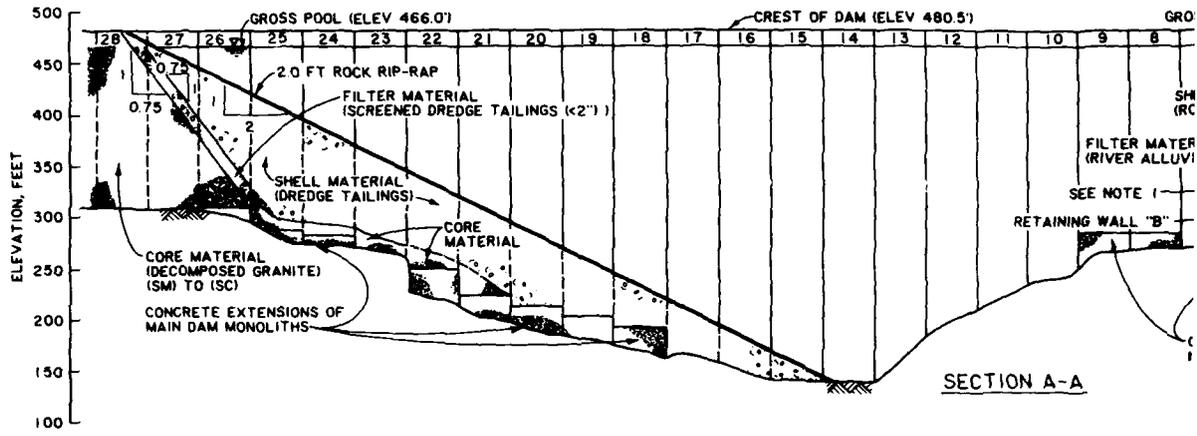
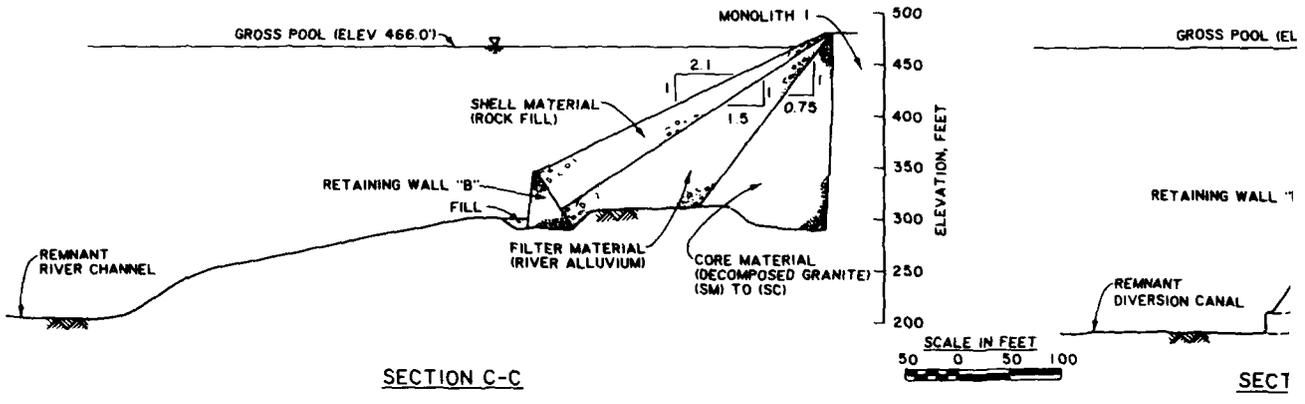
Figure 3. Plan and sections of upstream envelopment areas and Re

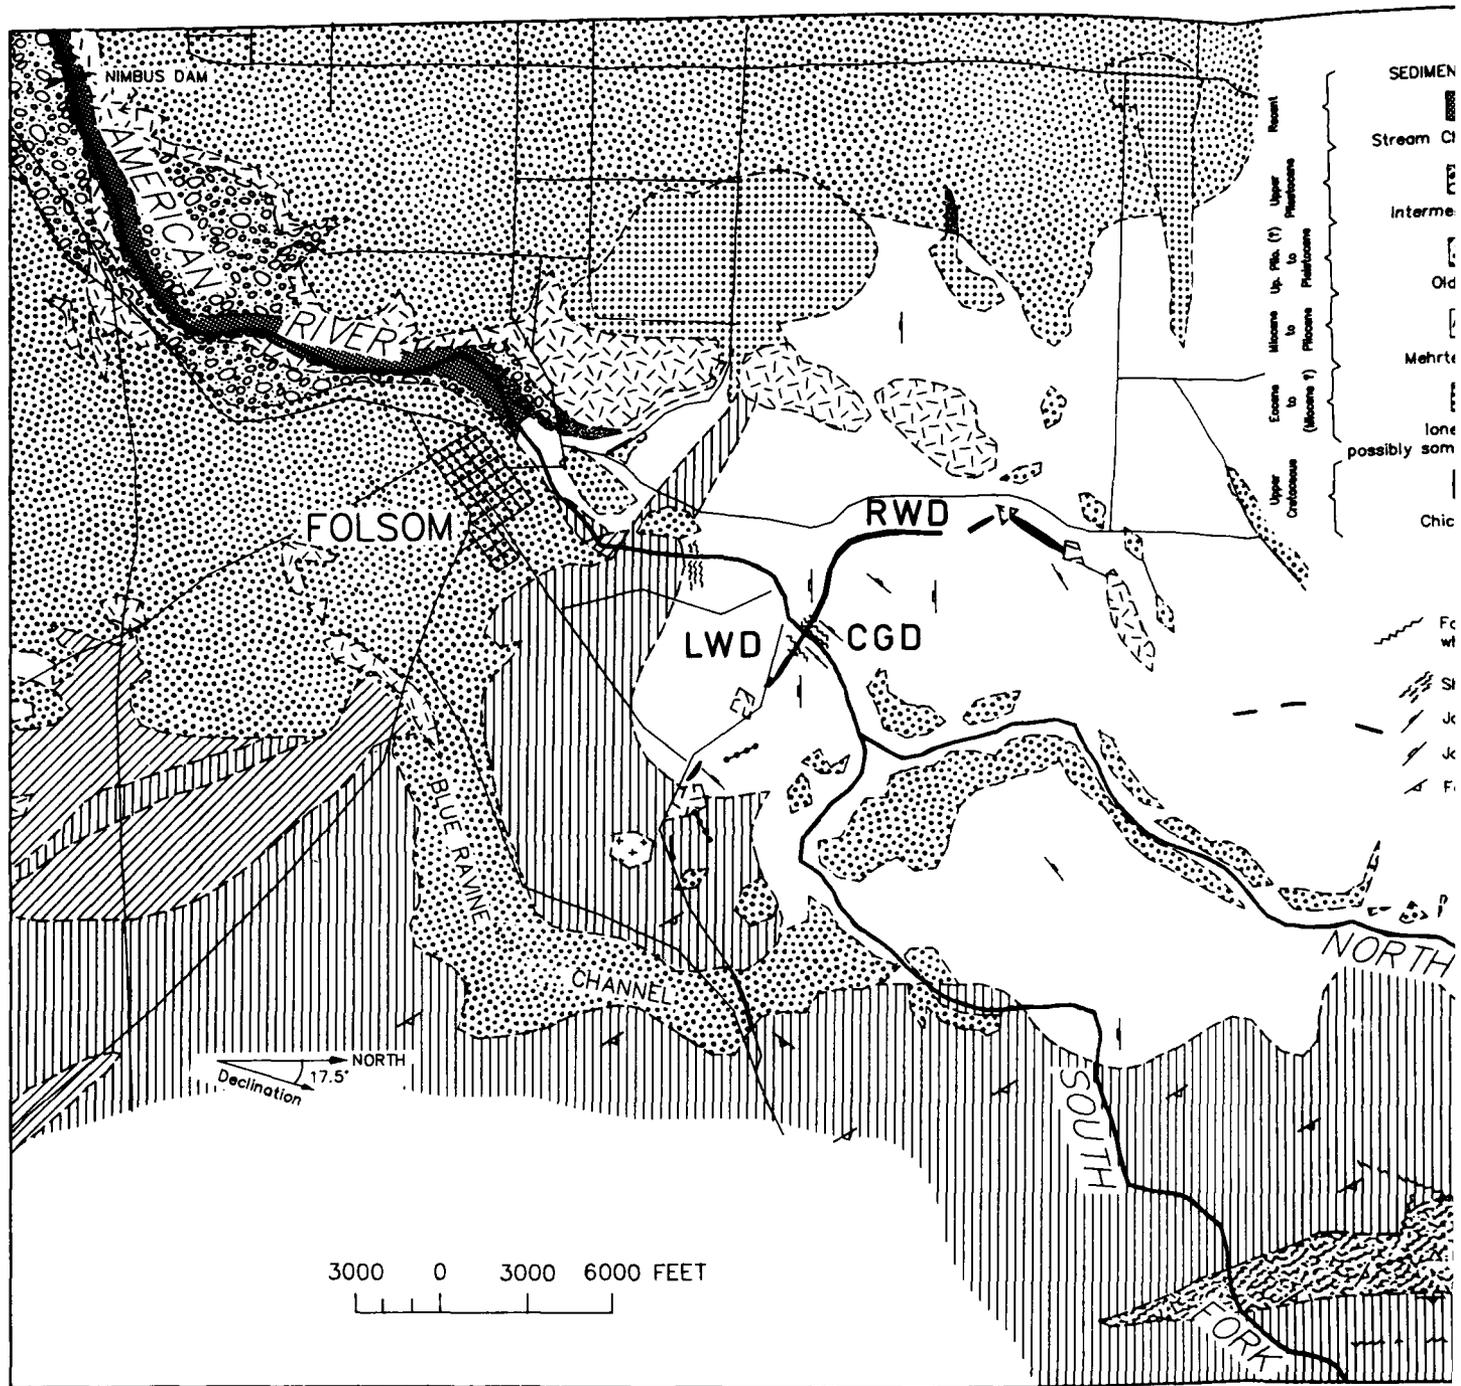
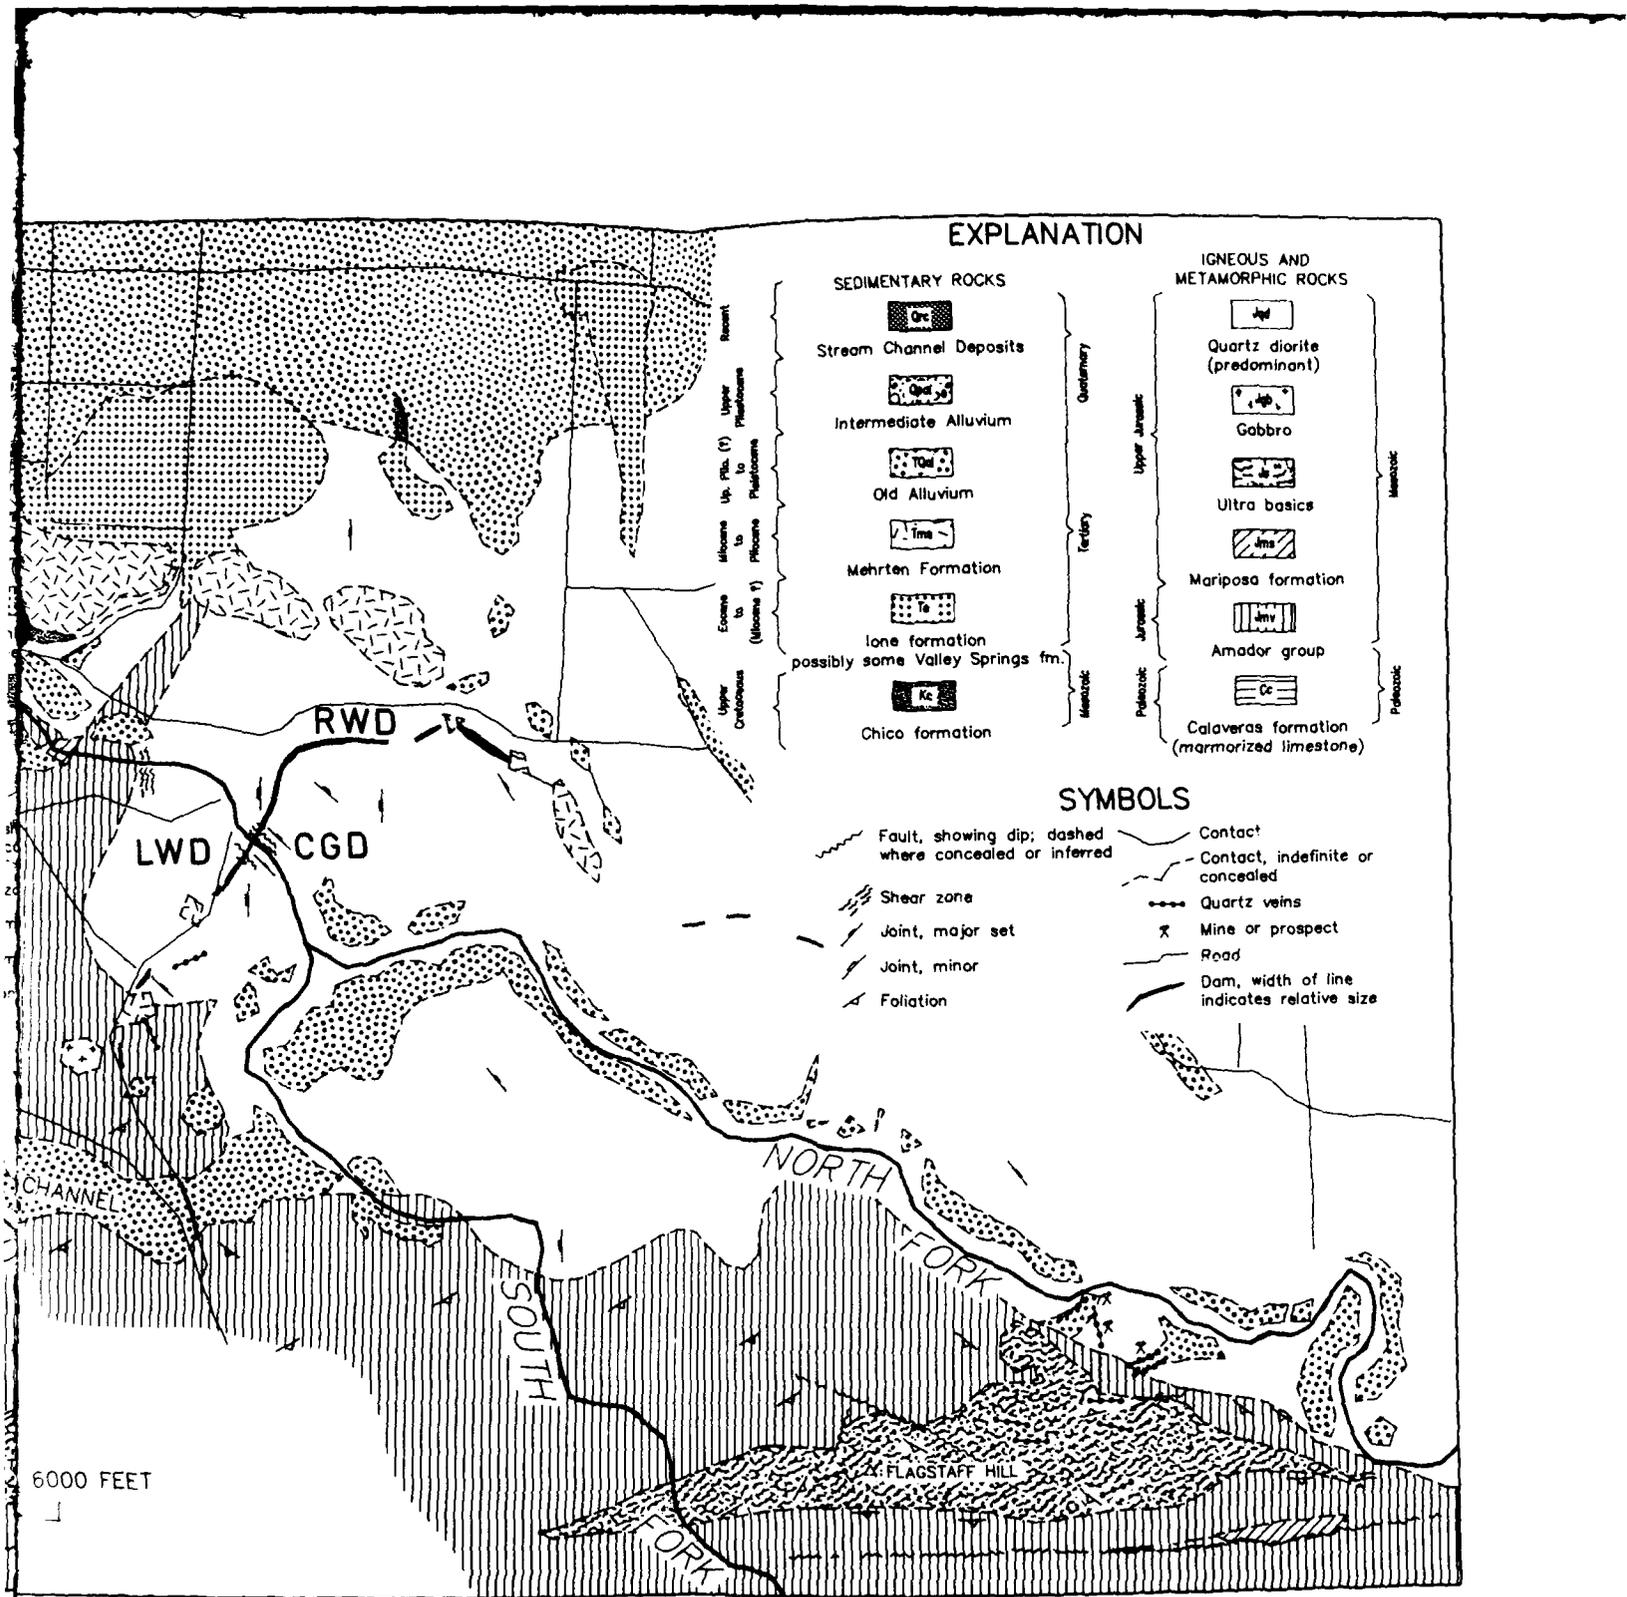
Figure 4. Geologic map, parts of the Folsom and Auburn quadrangles

14. At the time of construction, the geology and engineering geology concerns at the site were carefully detailed in the foundation reports by US Army Engineer District, Sacramento (1953). These foundation reports from construction records and a later paper by Kiersch and Treasher (1955) are the sources for the summary of site geology provided in this section. Figure 4 shows a geologic map of the project area.

17. The important formations at the dam site are: a quartz diorite granite which underlies the CGD, RWD, and LWD and Saddle Dikes 1 through 7; metamorphic rocks of the Amador group which underlie Saddle Dike 8 and the foundation at Mormon Island Auxiliary Dam; the Mehrten formation, a deposit of cobbles and gravels in a somewhat cemented clay matrix which caps the low hills that separate the saddle dikes and is part of the foundation at Dike 5; and the alluvium that fills the Blue Ravine at Mormon Island Auxiliary Dam. Bedrock geology is indicated on the plan in Figures 2 and 4.

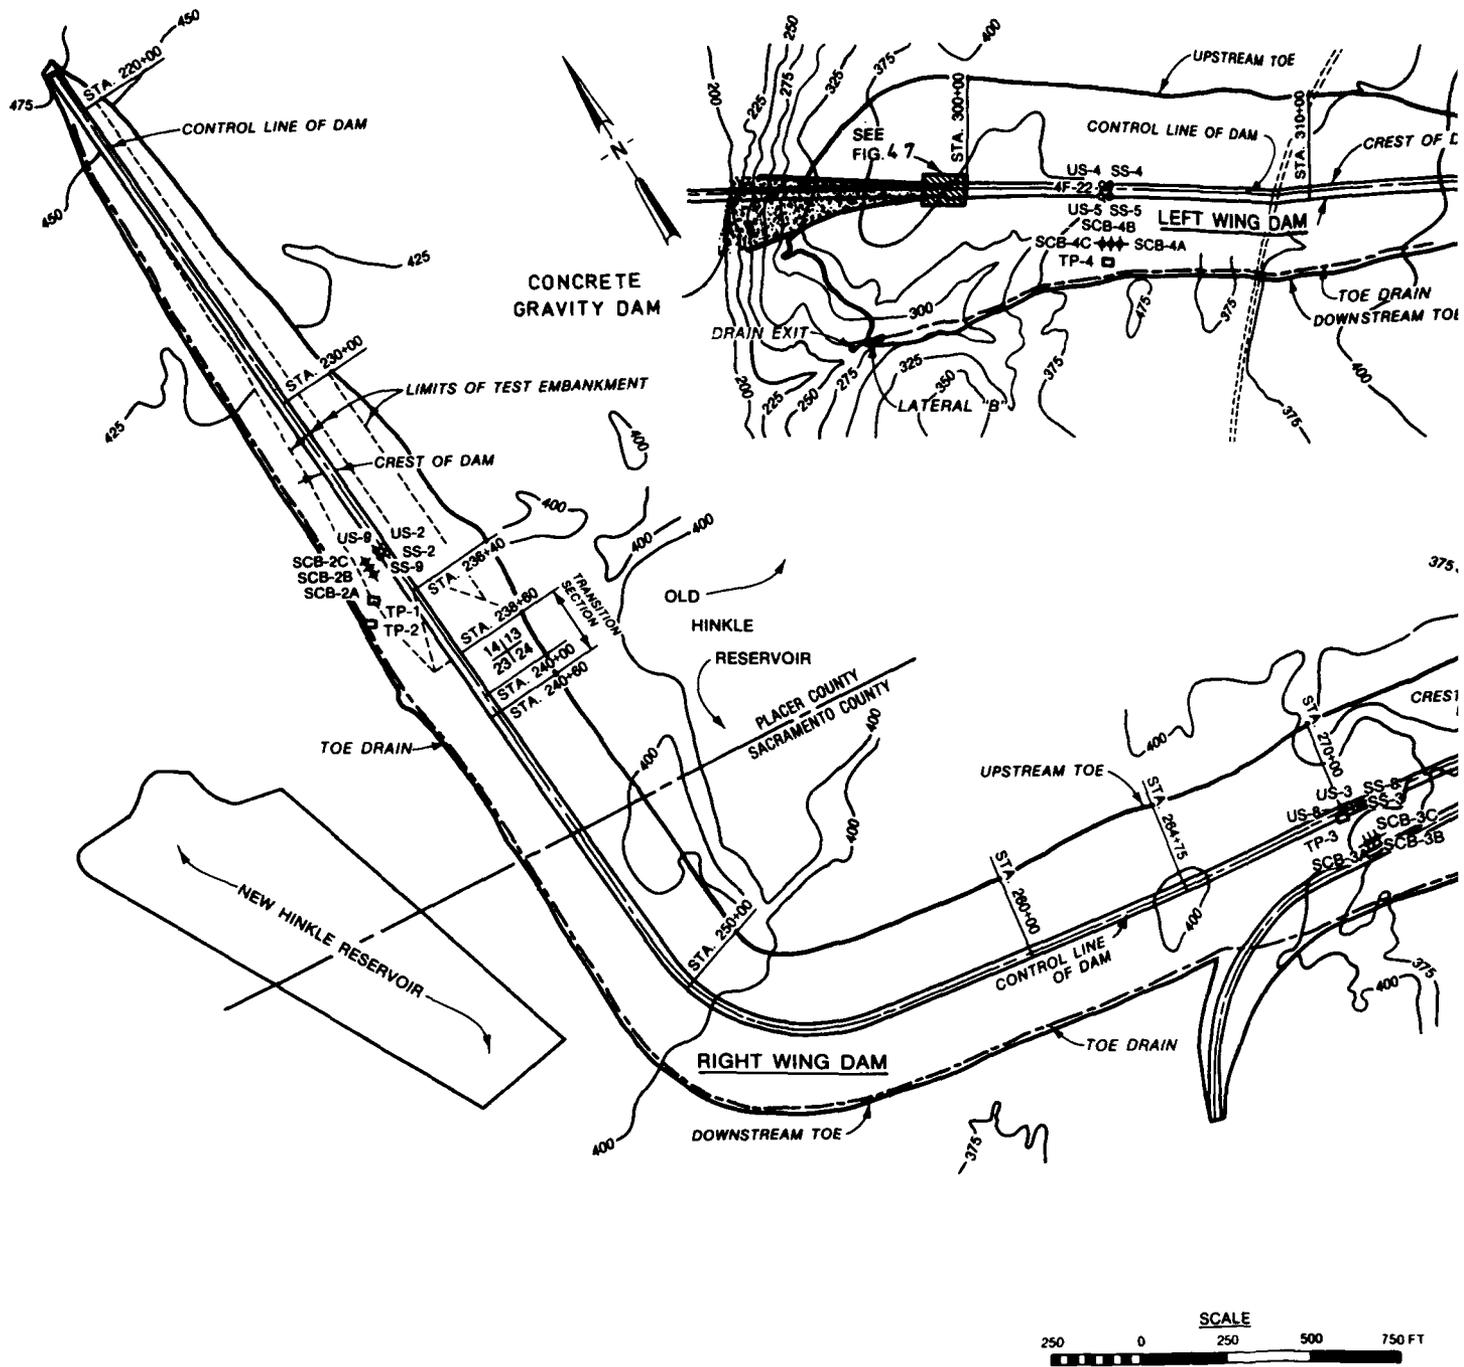
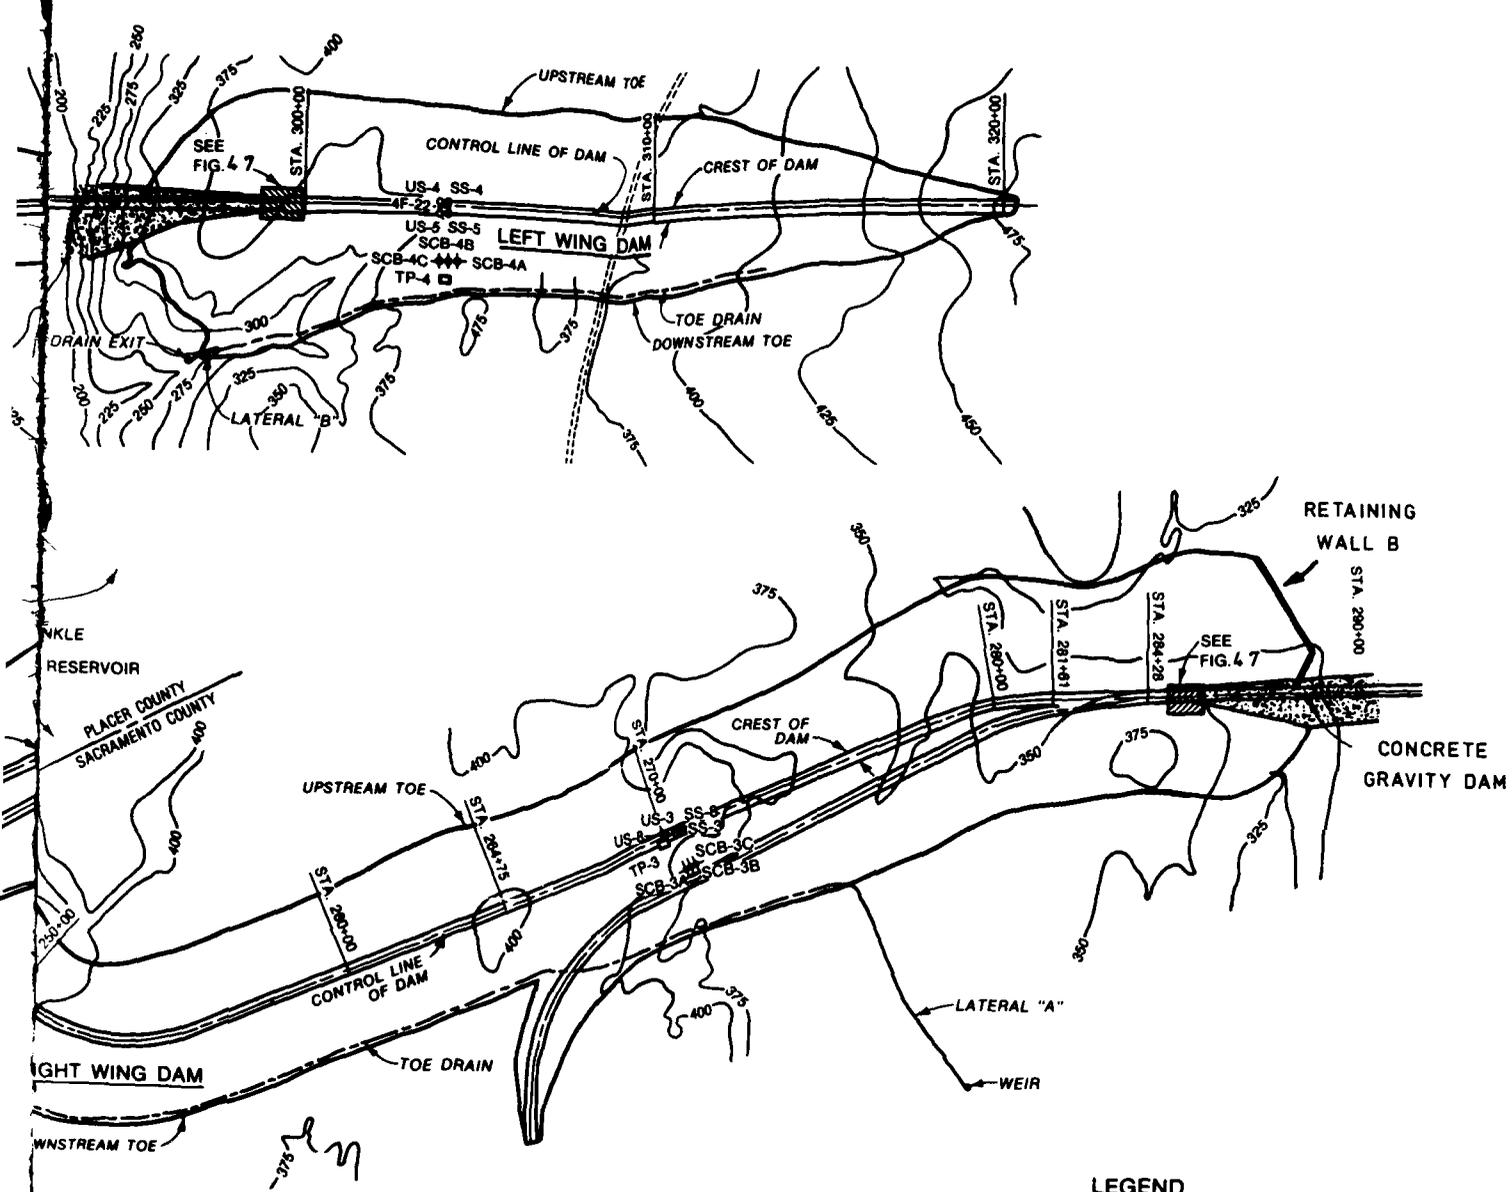
Plan view of Right and Left Wing Dams and detailed plan view of interface areas

30. The Wing Dams are zoned embankment dams founded on weathered quartz diorite granite. Plans of the Wing Dams are shown in Figures 2 and 7. The Right Wing Dam has a crest length of approximately 6,700 ft, and has a maximum height of approximately 195 ft. The core consists of well-compacted decomposed granite and suitable fine-grained materials from the American River channel. Gravels excavated from the American River channel were used as upstream and downstream transition zones. An uncompacted rock-fill shell was constructed on the upstream and downstream slopes over most of the length of the dam. The upstream slopes are 2.25 horizontal to 1 vertical, and the downstream slopes are 2 horizontal to 1 vertical. Typical sections are shown in Figure 8.

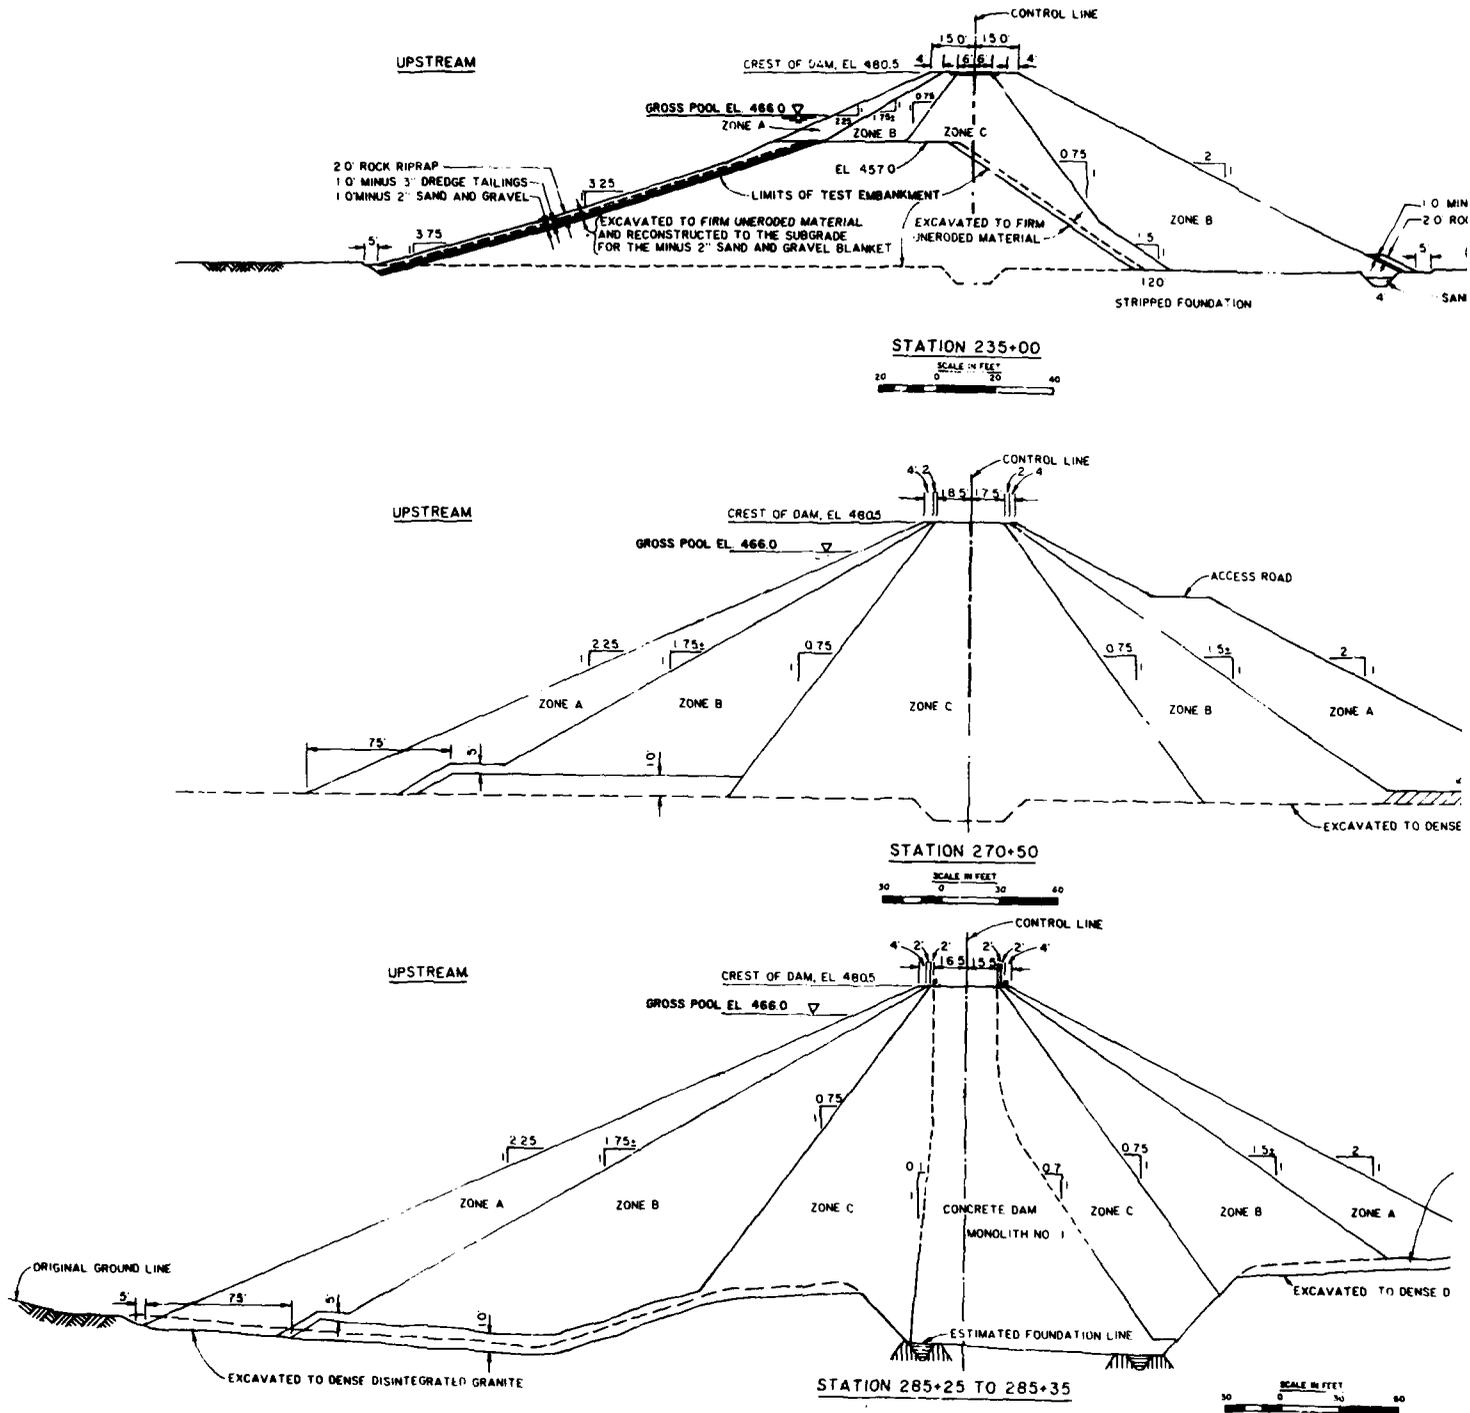
Figure 8. Typical cross-sections of RWD

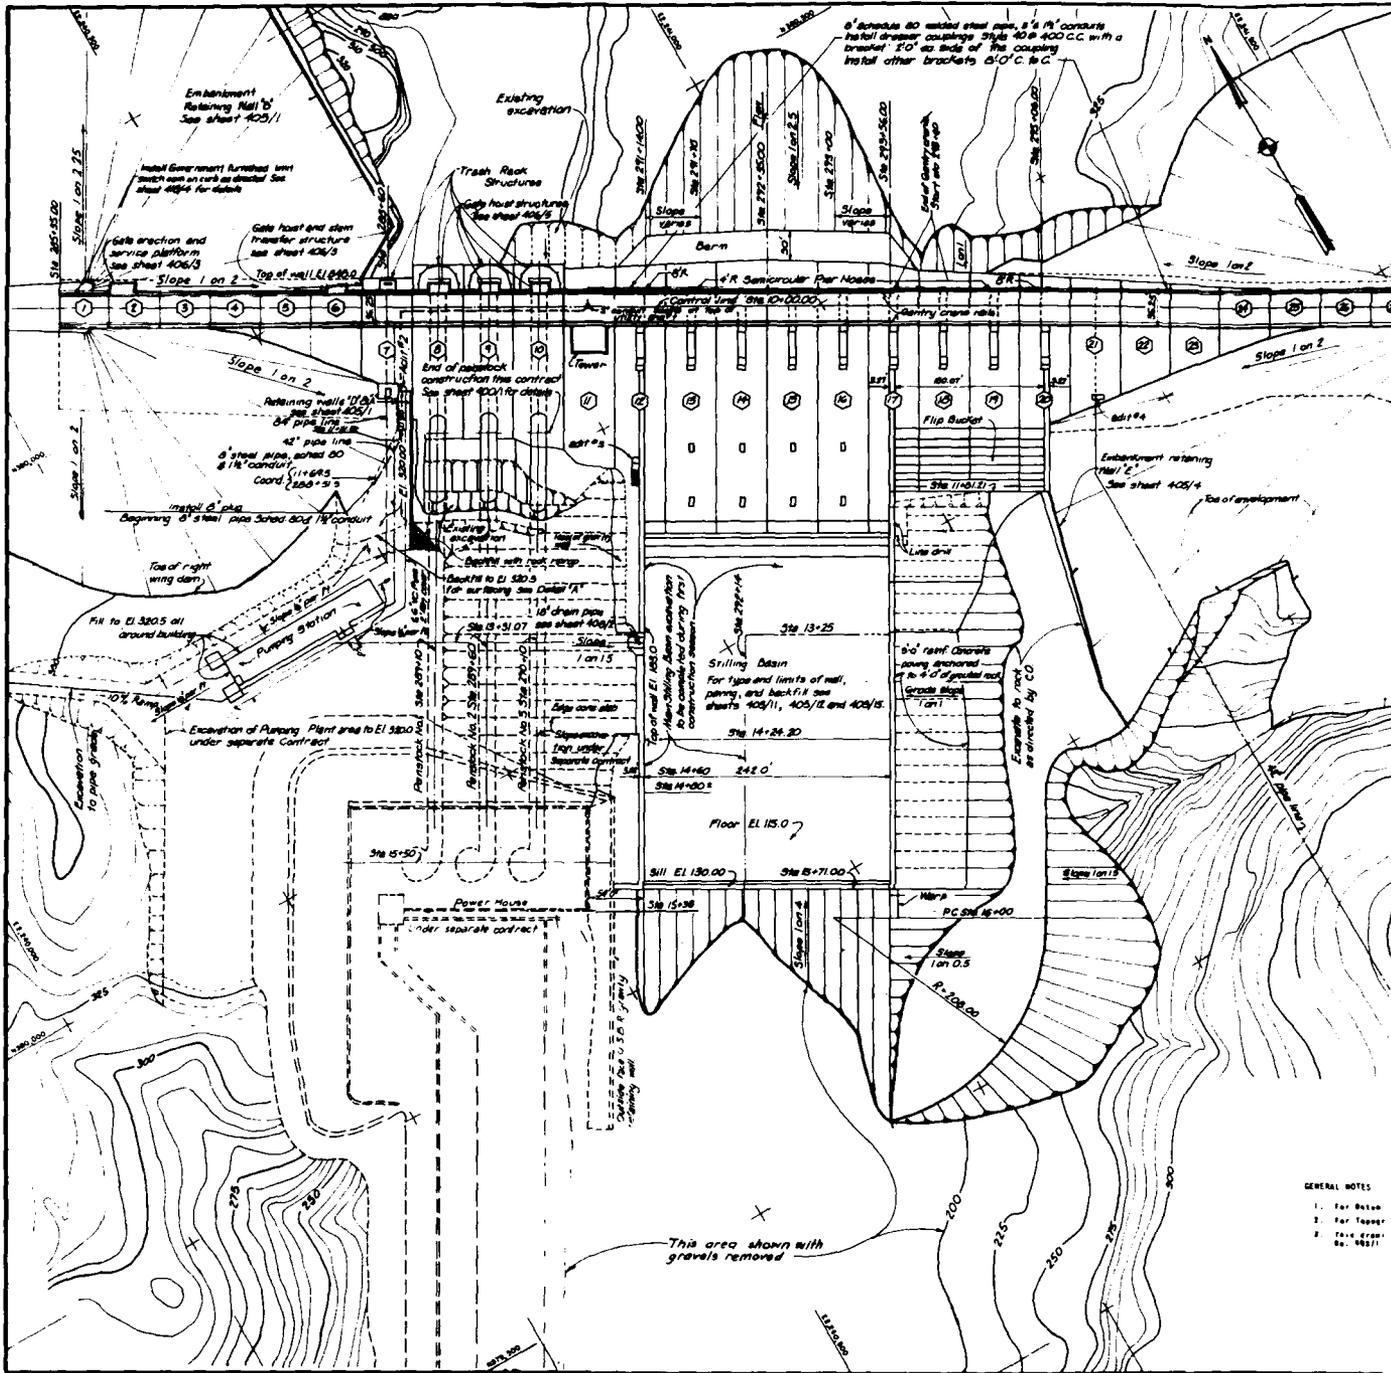
Figure 10. Plan of Concrete Gravity Dam

32. The Right and Left Wing Dams flank the Concrete Gravity Dam. The Concrete Gravity Dam consists of twenty eight 50-ft-wide monoliths founded on hard granodiorite rock. The overall length of the concrete structure is 1,400 ft, the maximum height is 340 ft measured from the foundation to the crown of the roadway, elevation 480.5 ft (3.5 ft below the top of parapet, elevation 484.0 ft), and the crest width is about 32 ft. Monoliths are numbered consecutively (1 through 28) beginning at the right abutment. Plans and elevations are shown in Figures 10 and 11.

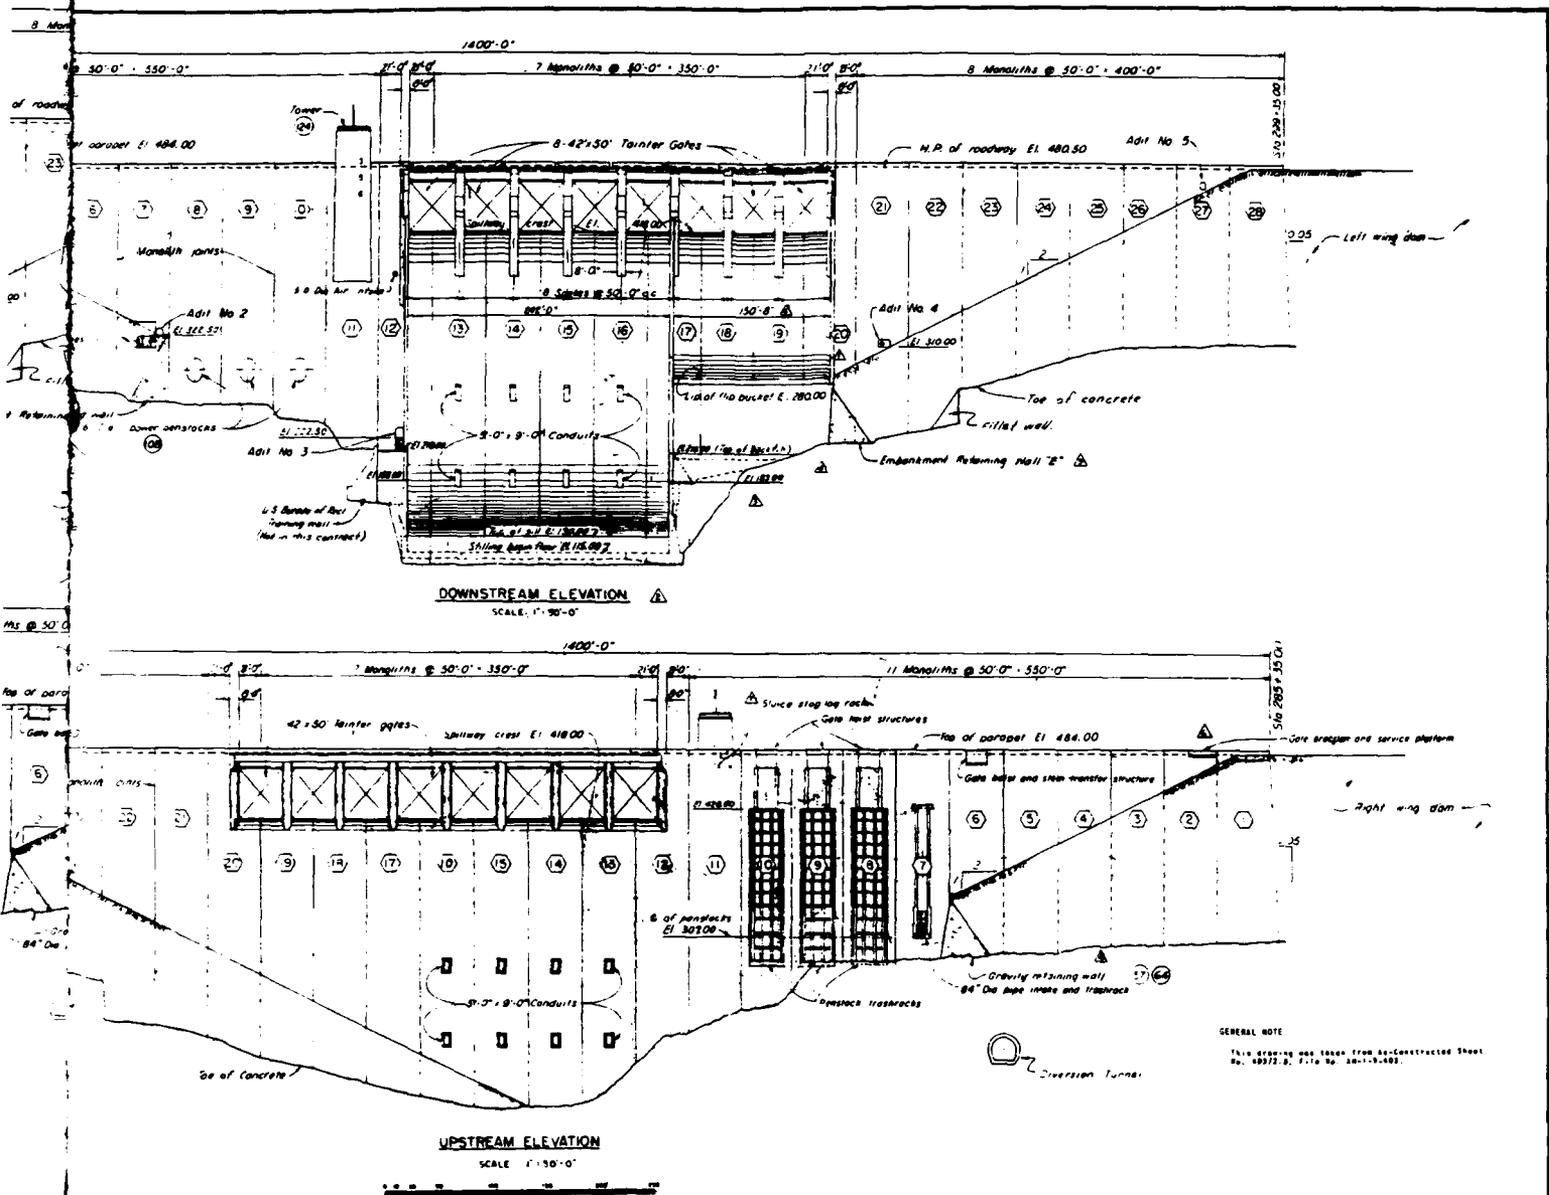
Figure 11. Concrete gravity dam elevations

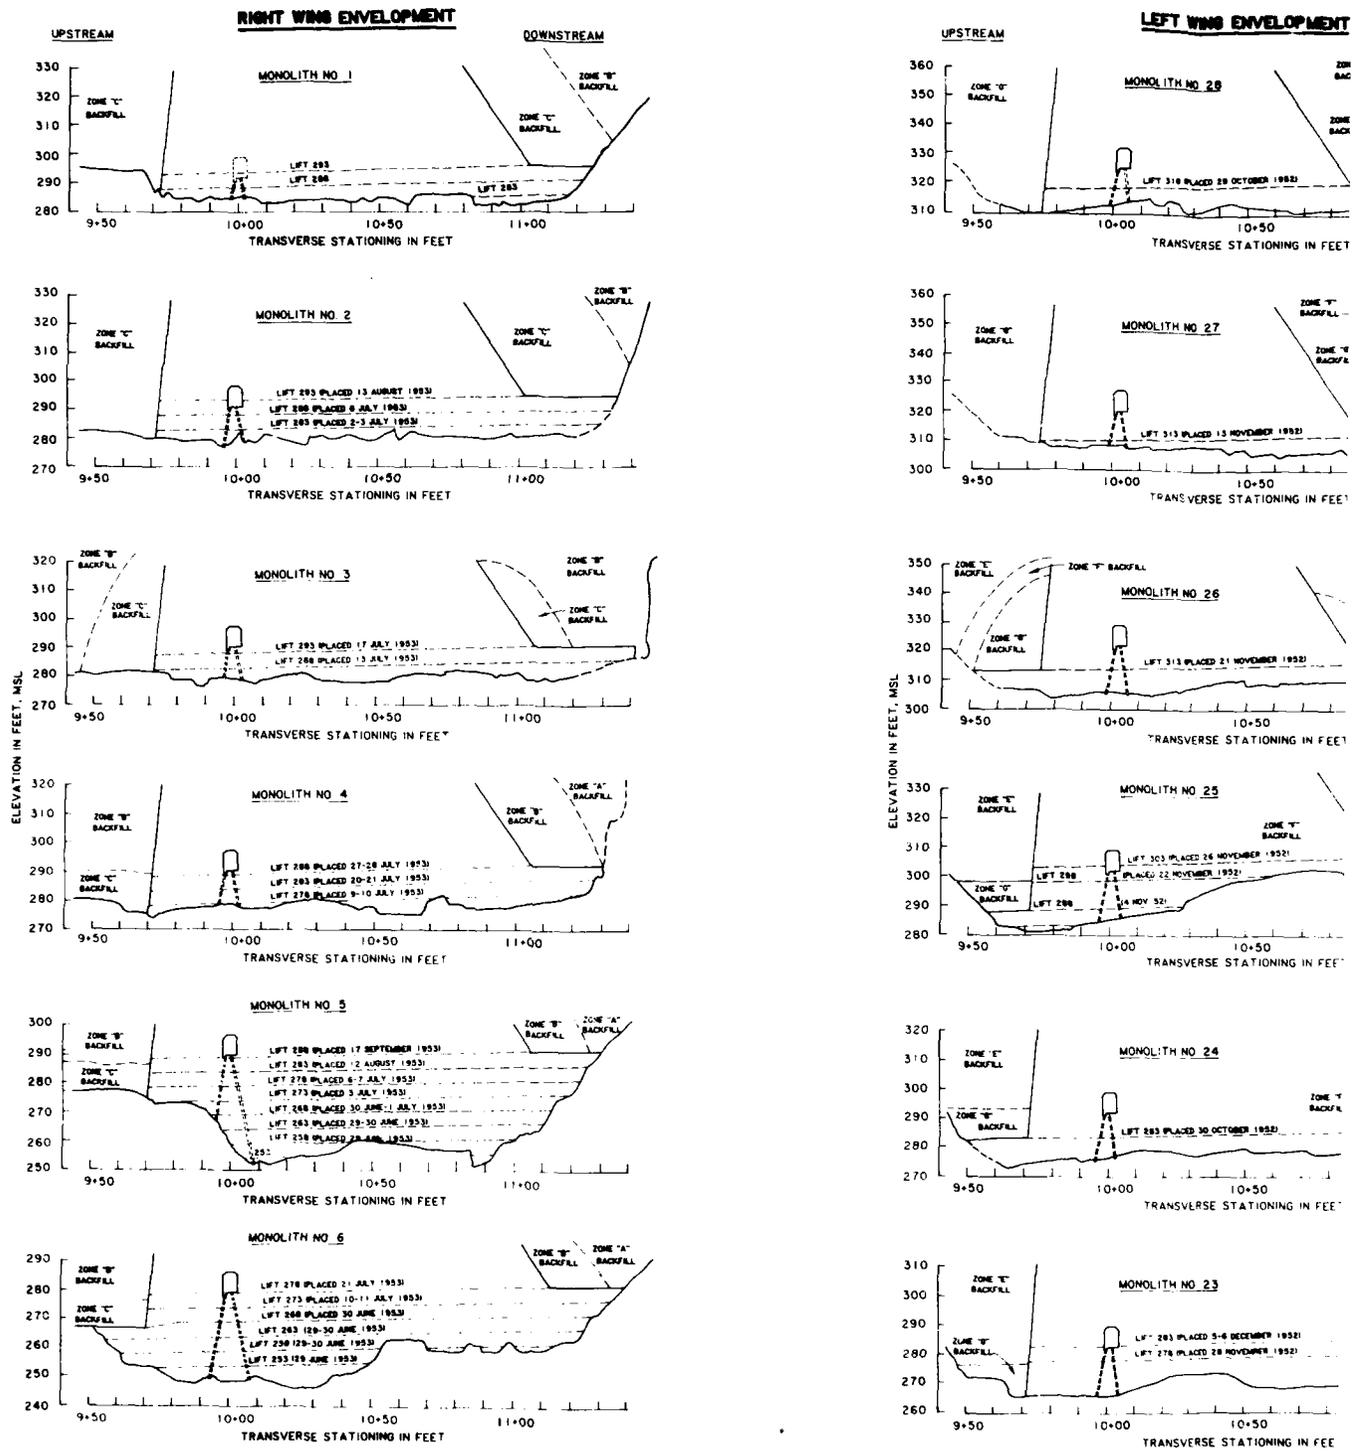
Figure 24. Transverse cross-sections of monoliths in intake structure.

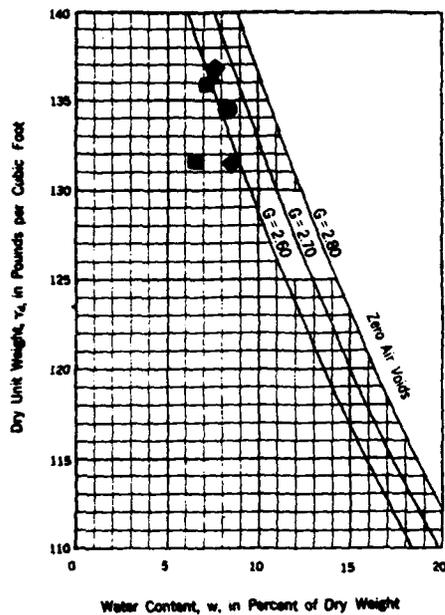
Figure 45. Ranges in results of moisture-density relationships at LWD interface zones

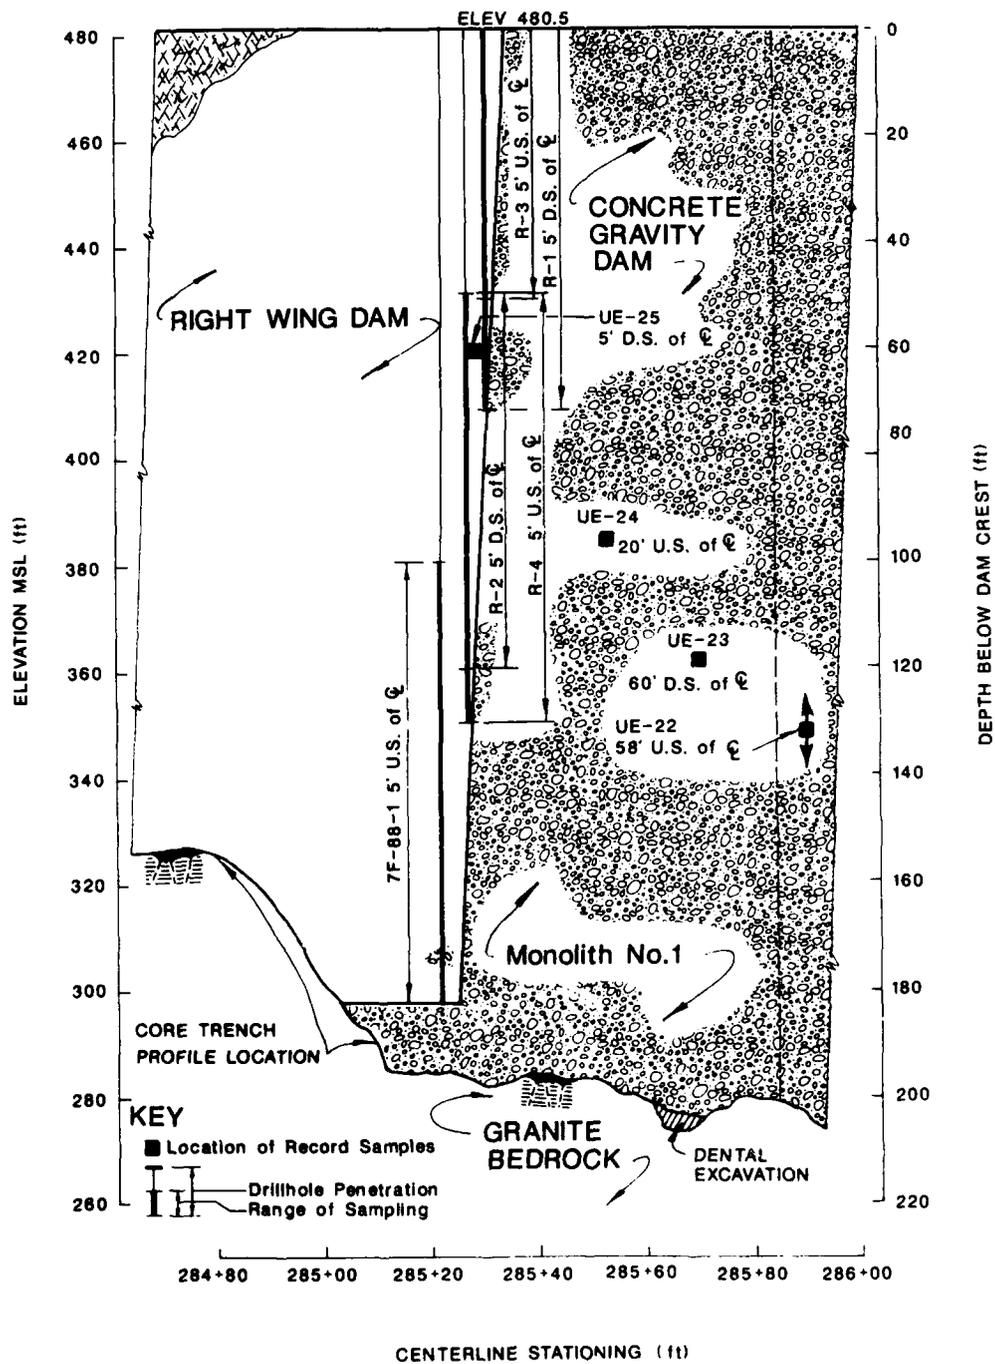
Figure 48. Profile along centerline at interface between RWD and CGD showing depths penetrated by drill holes and sample locations

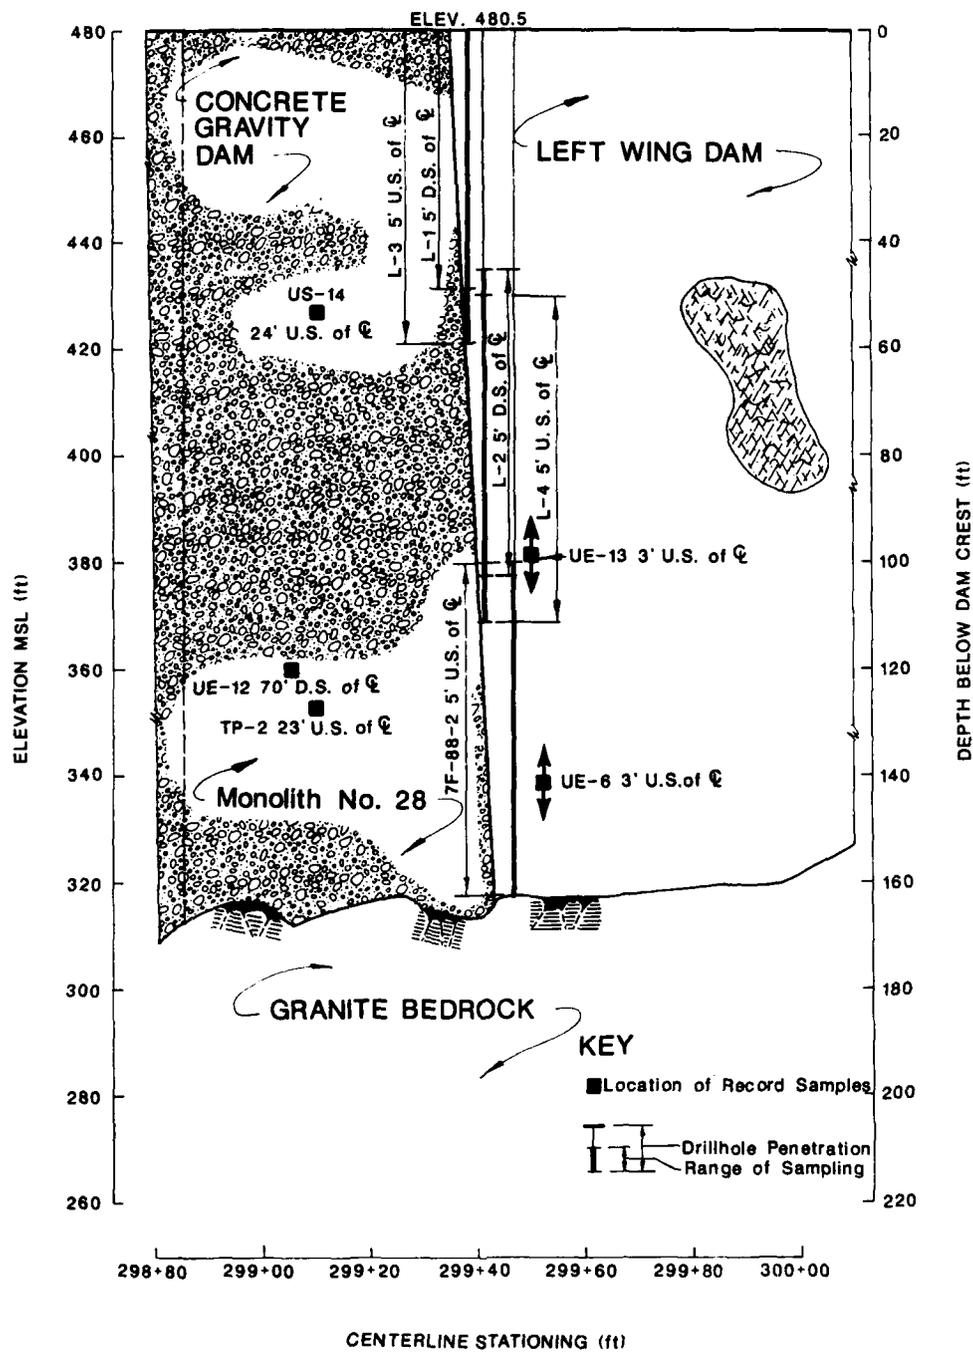
Figure 49. Profile along centerline at interface between LWD and CGD showing depths penetrated by drill holes and sample locations

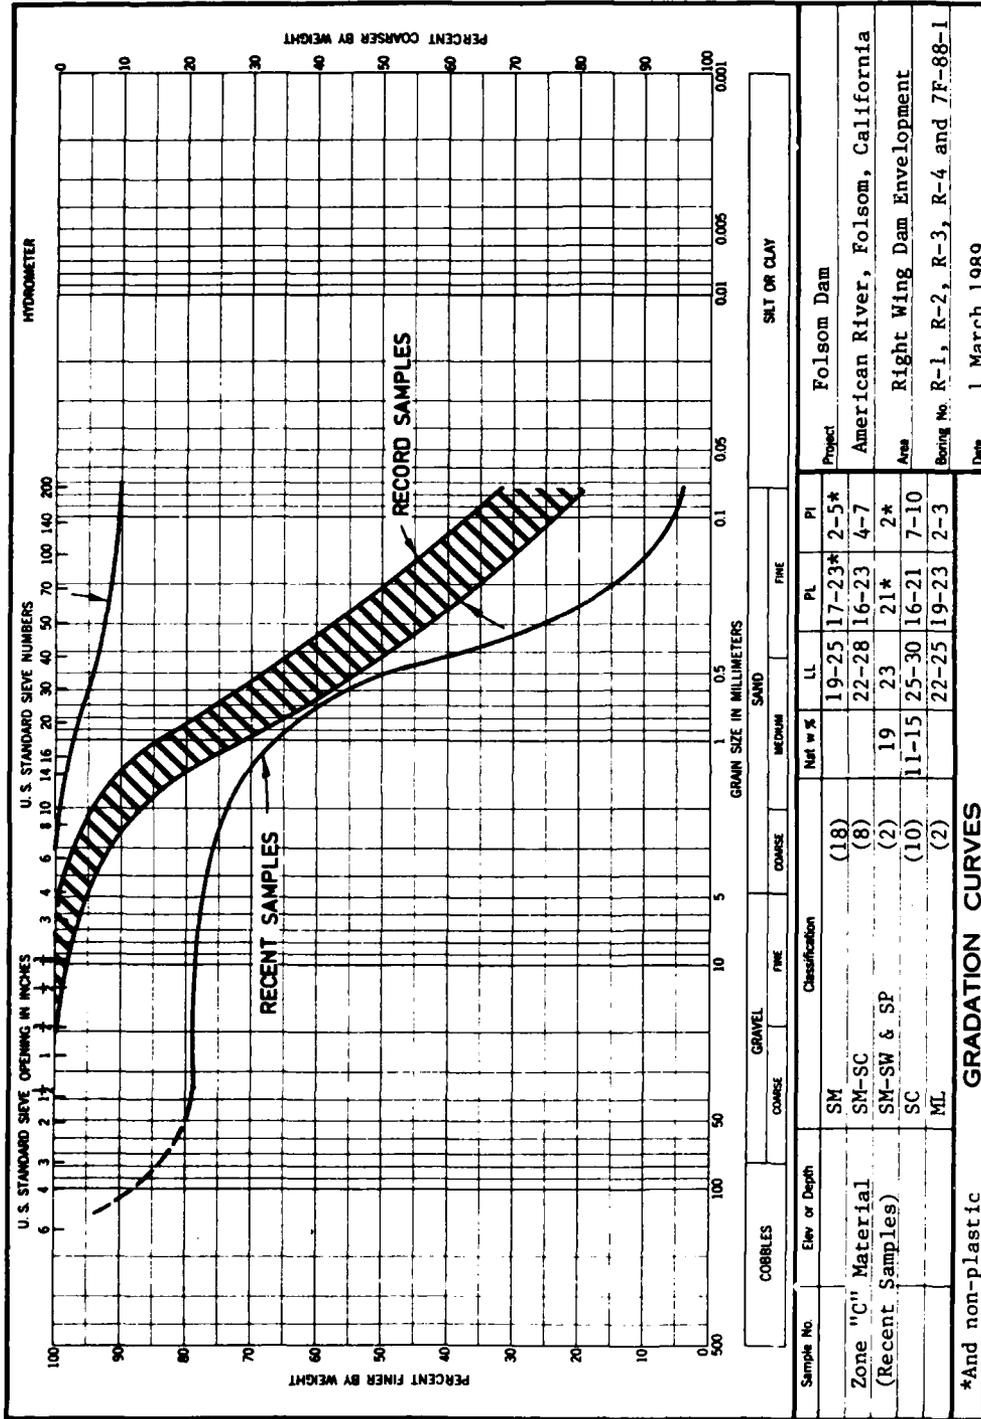
Figure 50. Comparison of ranges in grain size distribution of core material at RWD interface zones
